Washington State School Seismic Safety Assessments Project

SEISMIC ASSESSMENT REPORT

VOLUME 1 OF 5

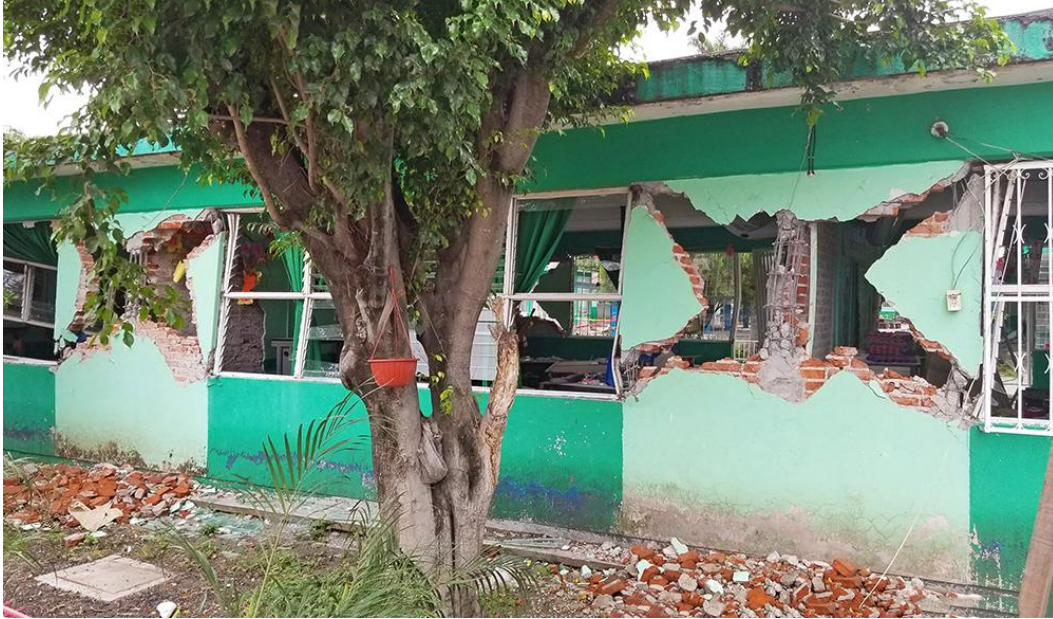
Figure 3.1.3-1. Structural Earthquake Damage to a Primary School in Central Mexico from the 2017 M7.1 Central Mexico Earthquake (Photo by Reid Middleton).
